**Flood Control Project Maintenance
Levee Inspections**

Fall 2018 Levee Maintenance Deficiency Summary Report

San Joaquin River Basin

Reclamation District No. 0017 Mossdale

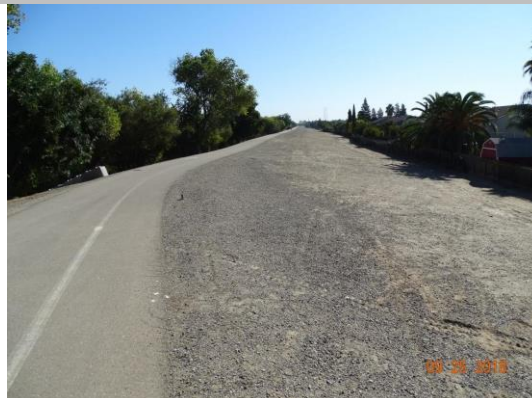
Photo 1 of 1 : FA_2018_RD0017_303_9_20180927_00018.jpg

LM Start	0.00	Rating **	A	Issue No.	9
LM End	1.76	Issue Type +	Ma	Location *	LS
Category	Earthen Levee			GPS Latitude/Longitude	
				Start	End
Item	Vegetation			37.911248 °	37.915962 °
				-121.291064 °	-121.320708 °
DWR ID	DWR_RD0017_01_f_2018_9				
Comment Code					
V1 : Control annual grass and weeds on the levee slopes and easements.					
Inspector Comment

Looking southwest at typical view of landward slope. (Fall 2018)

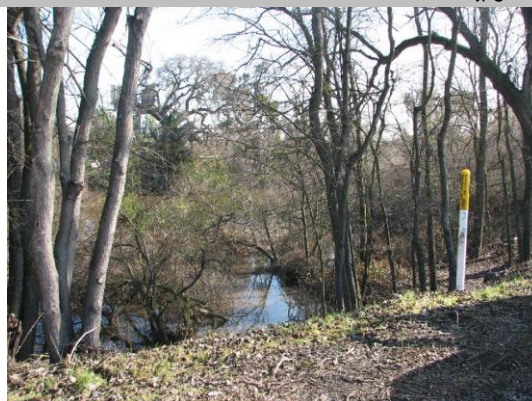
Photo 1 of 3 : UCIP_FA_2018_40603_38480.jpg

LM Start	0.03	Rating **	M	Issue No.	12	
LM End	0.03	Issue Type +	En	Location *		
Category	Supplemental			GPS Latitude/Longitude		
				Start	End	
Item	DWR UCIP Field Study			37.911561 °	37.911561 °	
				-121.291441 °	-121.291441 °	
DWR ID	1					
Comment Code						
Inspector Comment						
FS_ID:40603 DS_ID:1 EP_NO: 6623 Repair Type: Non-Urgent Crossing Status: Found UCIP Comments: Marker missing on landward side. Need to contact owner to determine status of crossing. Need date of last inspection and confirmation that crossing is still in operable condition. FIELD_STRUCT_DESC: 5.563-inch welded steel natural gas pipeline through the levees, 4.5 feet below the crown, across the channels and overflow area. (5-inch gas line authorized under Permit No. 6623, 1969 - Laymac Corporation) [Additional Reference(s): DWR Levee Logs, 1981, 2003]. FS Date: 2/3/2010

View of waterward side.

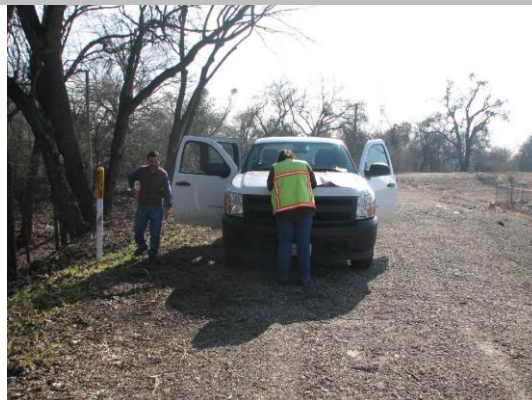
Photo 2 of 3 : UCIP_FA_2018_40603_38479.jpg

View of levee crown at crossing. Marker for line visible on waterward shoulder.

Comment Code						
Inspector Comment						
FS_ID:40603						
DS_ID:1						
EP_NO: 6623						
Repair Type: Non-Urgent						
Crossing Status: Found						
UCIP Comments: Marker missing on landward side. Need to contact owner to determine status of crossing. Need date of last inspection and confirmation that crossing is still in operable condition.						
FIELD_STRUCT_DESC: 5.563-inch welded steel natural gas pipeline through the levees, 4.5 feet below the crown, across the channels and overflow area. (5-inch gas line authorized under Permit No. 6623, 1969 - Laymac Corporation) [Additional Reference(s): DWR Levee Logs, 1981, 2003].						
FS Date: 2/3/2010

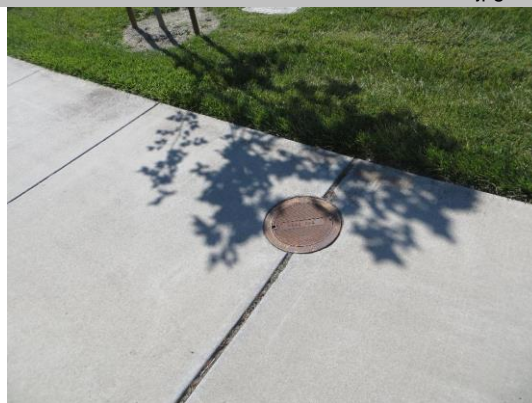
Photo 1 of 3 : UCIP_FA_2018_49990_74222.jpg

FS_ID:49990
DS_ID:72
EP_NO: 15185
Repair Type: Non-Urgent
Crossing Status: Indicator Found
UCIP Comments: 04/06/2018 Received supporting information from T. Marlow with KSN pertaining to line. PG&E has installed gas line distribution markers on both shoulder of the levee. Crossing is an active line. PG&E performs a leak survey at least twice a year according to Mr. R. Muok, Supervisor, Gas Pipeline Operations and Maintenance Stockton. Mr. Muok can be reached at 209-406-7926. Crossing has been downgraded from Urgent to Non-Urgent--pipe is inspected by owner. UCIP will need to coordinate with PG&E to obtain confirmation of inspections, obtain emergency contact information, and maintenance contact information. (DWR UCIP - O. Magana)
07/12/2016 No markers (no photos taken in 2016). Need to contact owner to determine status of crossing. If crossing is active, owner will need to coordinate with CVFPB to install markers to comply with Title 23. (DWR UCIP - omagana)5/19/2015 Need to install gasline markers. (DWR UCIP - omagana)

Gas access lid in sidewalk Approximately 200-feet to west of crown.

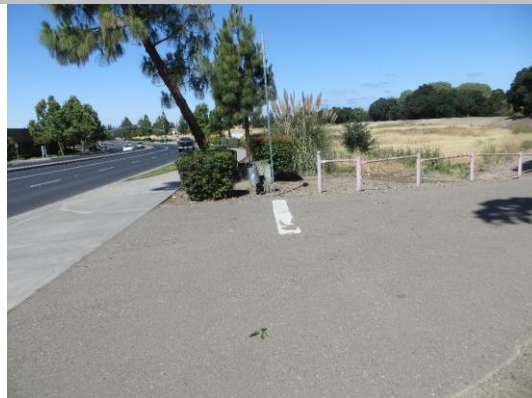
Photo 3 of 3 : UCIP_FA_2018_49990_74220.jpg

Comment Code						
Inspector Comment						
FS_ID:49990 DS_ID:72 EP_NO: 15185 Repair Type: Non-Urgent Crossing Status: Indicator Found UCIP Comments: 04/06/2018 Received supporting information from T. Marlow with KSN pertaining to line. PG&E has installed gas line distribution markers on both shoulder of the levee. Crossing is an active line. PG&E performs a leak survey at least twice a year according to Mr. R. Muok, Supervisor, Gas Pipeline Operations and Maintenance Stockton. Mr. Muok can be reached at 209-406-7926. Crossing has been downgraded from Urgent to Non-Urgent--pipe is inspected by owner. UCIP will need to coordinate with PG&E to obtain confirmation of inspections, obtain emergency contact information, and maintenance contact information. (DWR UCIP - O. Magana) 07/12/2016 No markers (no photos taken in 2016). Need to contact owner to determine status of crossing. If crossing is active, owner will need to coordinate with CVFPB to install markers to comply with Title 23. (DWR UCIP - omagana)5/19/2015 Need to install gasline markers. (DWR UCIP - omagana) FIELD_STRUCT_DESC: 8-inch soil proofed steel gas main through the left bank levee and under the channel of French Camp Slough. The pipeline has a minimum cover of 20 to 25 feet within the overflow areas and under the channel. (8-inch line authorized under Permit No. 15185, 1989 - Pacific Gas & Electric Company [PG&E]) FS Date: 7/12/2016

LS crown. No gasline markers.

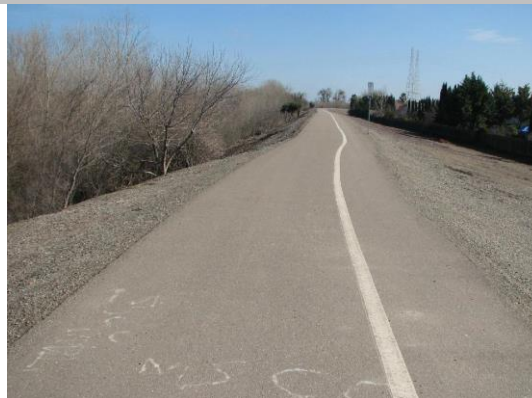
Photo 1 of 3 : UCIP_FA_2018_40604_38491.jpg

Comment Code						
Inspector Comment						
FS_ID:40604						
DS_ID:2						
EP_NO: 14992						
Repair Type: Non-Urgent						
Crossing Status: Indicator Found						
UCIP Comments: Need to contact owner to determine status of crossing. Also need date of last inspection.						
FIELD_STRUCT_DESC: [Weston Ranch - French Camp Slough Crossings] 1 of 3. 30-inch high-density polyethylene (HDPE) sewer force main (SFM) through the levee, 32 feet below levee crown. All pipes encased in concrete. (two 30-inch force mains (originally issued as 27-inch) and one 12-inch pipe authorized under Permit No. 14992, 1989 - City of Stockton and Richard Blewett) [Additional Reference(s): DWR Levee Logs, 1981, 2003]						
FS Date: 2/3/2010

Overview of levee crown at crossing.

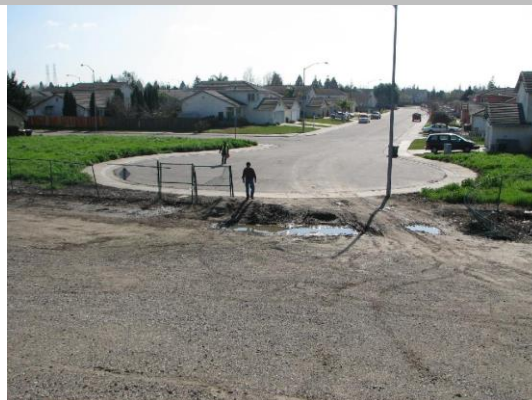
Photo 2 of 3 : UCIP_FA_2018_40604_38489.jpg

View of landward side.

Comment Code						
Inspector Comment						
FS_ID:40604						
DS_ID:2						
EP_NO: 14992						
Repair Type: Non-Urgent						
Crossing Status: Indicator Found						
UCIP Comments: Need to contact owner to determine status of crossing. Also need date of last inspection.						
FIELD_STRUCT_DESC: [Weston Ranch - French Camp Slough Crossings] 1 of 3. 30-inch high-density polyethylene (HDPE) sewer force main (SFM) through the levee, 32 feet below levee crown. All pipes encased in concrete. (two 30-inch force mains (originally issued as 27-inch) and one 12-inch pipe authorized under Permit No. 14992, 1989 - City of Stockton and Richard Blewett) [Additional Reference(s): DWR Levee Logs, 1981, 2003]						
FS Date: 2/3/2010

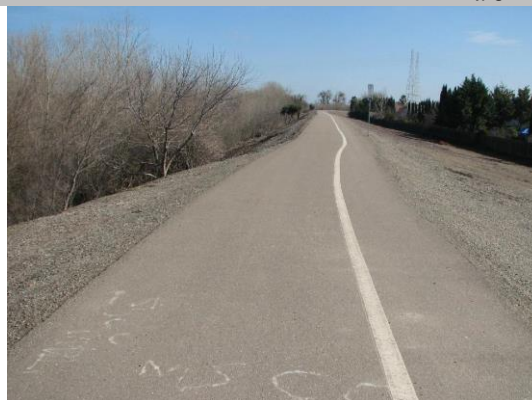
Photo 1 of 3 : UCIP_FA_2018_52614_38505.jpg

Comment Code						
Inspector Comment						
FS_ID:52614						
DS_ID:159						
EP_NO: 14992						
Repair Type: Non-Urgent						
Crossing Status: Indicator Found						
UCIP Comments: Need to contact owner to determine status of crossing. Also need date of last inspection.						
FIELD_STRUCT_DESC: [Weston Ranch - French Camp Slough Crossings] 2 of 3. 30-inch high-density polyethylene (HDPE) sewer force main (SFM) through the levee, 32 feet below levee crown. All pipes encased in concrete. (two 30-inch force mains (originally issued as 27-inch) and one 12-inch pipe authorized under Permit No. 14992, 1989 - City of Stockton and Richard Blewett) [Additional Reference(s): DWR Levee Logs, 1981, 2003]						
FS Date: 2/3/2010

Overview of levee at crossing.

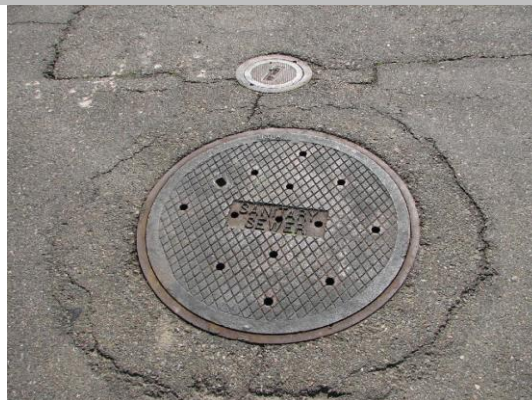
Photo 3 of 3 : UCIP_FA_2018_52614_38509.jpg

Comment Code						
Inspector Comment						
FS_ID:52614						
DS_ID:159						
EP_NO: 14992						
Repair Type: Non-Urgent						
Crossing Status: Indicator Found						
UCIP Comments: Need to contact owner to determine status of crossing. Also need date of last inspection.						
FIELD_STRUCT_DESC: [Weston Ranch - French Camp Slough Crossings] 2 of 3. 30-inch high-density polyethylene (HDPE) sewer force main (SFM) through the levee, 32 feet below levee crown. All pipes encased in concrete. (two 30-inch force mains (originally issued as 27-inch) and one 12-inch pipe authorized under Permit No. 14992, 1989 - City of Stockton and Richard Blewett) [Additional Reference(s): DWR Levee Logs, 1981, 2003]						
FS Date: 2/3/2010

Manhole for sanitary sewer visible on landward side.

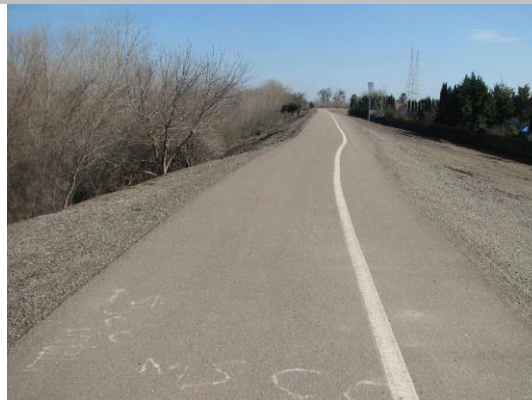
Photo 1 of 3 : UCIP_FA_2018_40606_71942.jpg

Comment Code						
Inspector Comment						
FS_ID:40606						
DS_ID:158						
EP_NO: 14992						
Repair Type: Non-Urgent						
Crossing Status: Indicator Found						
UCIP Comments: Need to contact owner to determine status of crossing. Also need date of last inspection.						
FIELD_STRUCT_DESC: [Weston Ranch - French Camp Slough Crossings] 3 of 3. 12-inch high-density polyethylene (HDPE) sewer force main (SFM) through the levee, 32 feet below levee crown. All pipes encased in concrete. (two 30-inch force mains (originally issued as 27-inch) and one 12-inch pipe authorized under Permit No. 14992, 1989 - City of Stockton and Richard Blewett) [Additional Reference(s): DWR Levee Logs, 1981, 2003]						
FS Date: 2/3/2010

View of levee crown at crossing.

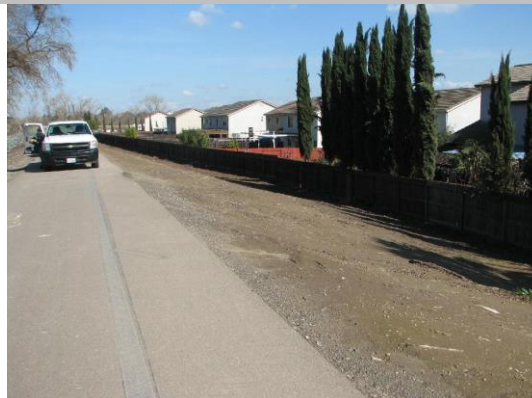
Photo 1 of 3 : UCIP_FA_2018_40628_38516.jpg

Comment Code						
Inspector Comment						
FS_ID:40628						
DS_ID:75						
EP_NO: 15093						
Repair Type: Non-Urgent						
Crossing Status: Found						
UCIP Comments: Only appurtenances remaining at this location--4 pillings located on waterward side. According to records the pillings were to be removed under a completion maintenace contract. Need to coordinate with owner.						
FIELD_STRUCT_DESC: 14-inch-diameter pipeline through levee at unknown depth. Per inspector's notes "this crossing is abandoned almost all materials removed including pipes, conduit, and pump house. The only items left are 4 pilings which are to be removed under a completion maintenance contract. Approximately 200 feet of reinforced concrete pipe lateral removed in R/W south of crossing".						
FS Date: 2/3/2010

View of landward side.

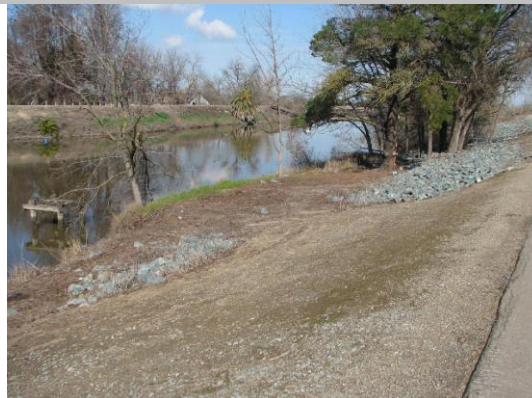
Photo 3 of 3 : UCIP_FA_2018_40628_38514.jpg

Comment Code						
Inspector Comment						
FS_ID:40628						
DS_ID:75						
EP_NO: 15093						
Repair Type: Non-Urgent						
Crossing Status: Found						
UCIP Comments: Only appurtenances remaining at this location--4 pillings located on waterward side. According to records the pillings were to be removed under a completion maintenace contract. Need to coordinate with owner.						
FIELD_STRUCT_DESC: 14-inch-diameter pipeline through levee at unknown depth. Per inspector's notes "this crossing is abandoned almost all materials removed including pipes, conduit, and pump house. The only items left are 4 pilings which are to be removed under a completion maintenance contract. Approximately 200 feet of reinforced concrete pipe lateral removed in R/W south of crossing".						
FS Date: 2/3/2010

View of waterward side.

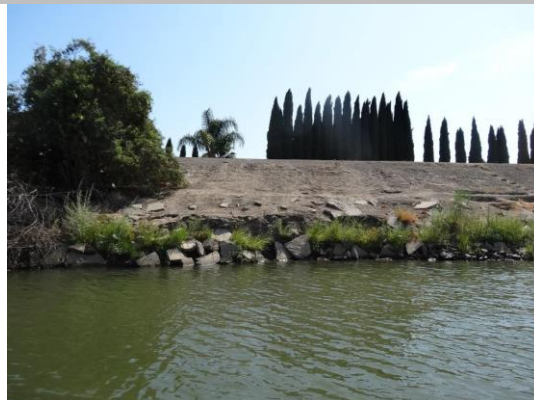
Photo 2 of 2 : FA_2018_RD0017_304_2_20180906_00006.jpg

LM Start	0.25	Rating **	M	Issue No.	2 (cont)	
LM End	0.26	Issue Type +	Ma	Location *	WS	
Category	Supplemental			GPS Latitude/Longitude		
				Start		End
Item	DWR Erosion Survey			37.913048 °	37.913048 °	
				-121.323561 °	-121.323561 °	
DWR ID	RD0017U02RM43.51					
Comment Code						
Inspector Comment						
09/13/2017: Erosion occurs along the levee toe. [2017 Site ID:RD0017U02RM43.51].

Close view of the erosion.

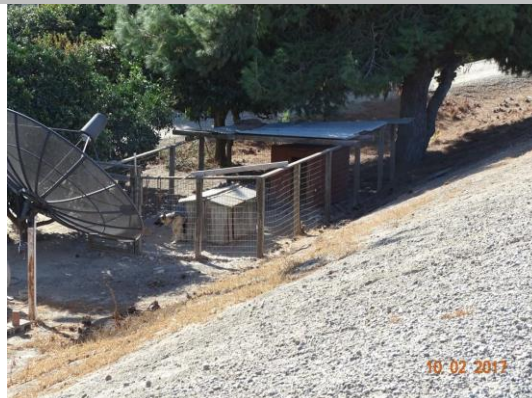
Photo 1 of 1 : FA_2018_RD0017_304_73_20180906_00012.jpg

LM Start	1.13	Rating **	M	Issue No.	73
LM End	1.13	Issue Type +	En	Location *	LS
Category	Earthen Levee			GPS Latitude/Longitude	
				Start	End
Item	Encroachments			37.901693 °	37.901693 °
				-121.325582 °	-121.325582 °
DWR ID	DWR_RD0017_02_s_2017_73				
Comment Code					
BU : Building					
Inspector Comment

Looking southeast at the landside slope.

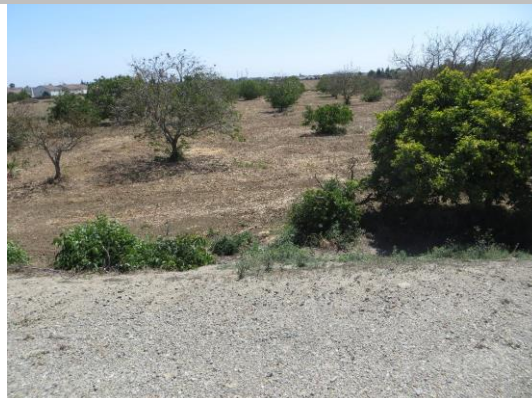
Photo 2 of 2 : UCIP_FA_2018_45449_74104.jpg

LM Start	1.18	Rating **	M	Issue No.	89 (cont)	
LM End	1.18	Issue Type +	En	Location *		
Category	Supplemental			GPS Latitude/Longitude		
				Start	End	
Item	DWR UCIP Field Study			37.901012 °	37.901012 °	
				-121.325497 °	-121.325497 °	
DWR ID	9					
Comment Code						
Inspector Comment						
FS_ID:45449						
DS_ID:9						
EP_NO: N/A						
Repair Type: Non-Urgent						
Crossing Status: Indicator Found						
UCIP Comments: Appears abandoned. Should contact owner to determine status as signs have been removed from supports and should be replaced if still in service.						
FIELD_STRUCT_DESC: Underground telephone cable through levee, 2 feet below crown. Warning signs on waterside (WS) slope. [Additional Reference(s): DWR Levee Logs, 1981, 2003]						
FS Date: 5/19/2015

No markers on LS.

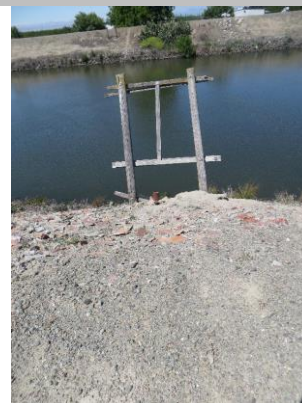
Photo 1 of 2 : UCIP_FA_2018_45450_74107.jpg

LM Start	1.18	Rating **	M	Issue No.	90	
LM End	1.18	Issue Type +	En	Location *		
Category	Supplemental			GPS Latitude/Longitude		
				Start		End
Item	DWR UCIP Field Study			37.901012 °		37.901012 °
				-121.325497 °		-121.325497 °
DWR ID	308					
Comment Code						
Inspector Comment						
FS_ID:45450 DS_ID:308 EP_NO: N/A Repair Type: Non-Urgent Crossing Status: Indicator Found UCIP Comments: Appears Abandoned. Need to contact owner to determine status of crossing as signs have been removed from markers and should be replaced if still in service. FIELD_STRUCT_DESC: 4-inch submarine telephone cable of unknown material through the levee, 2 feet below the crown, and across the channel. Location marker on the waterside (WS) slope. [Additional Reference(s): DWR Levee Logs, 1981, 2003] FS Date: 5/19/2015

Sign post on WS slope.

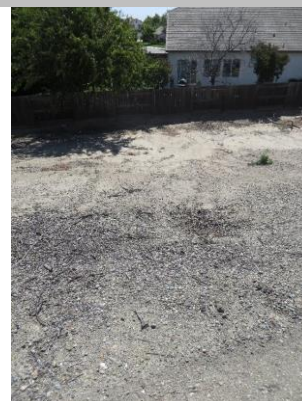
Photo 2 of 2 : UCIP_FA_2018_49637_74108.jpg

Comment Code						
Inspector Comment						
FS_ID:49637 DS_ID:10 EP_NO: 15098 Repair Type: Non-Urgent Crossing Status: Indicator Found UCIP Comments: 5/19/2015 Only signs of electrical conduit found. Need to contact owner to determine status of pipe as no record of removal has been found and only an electrical conduit was found at this location. (DWR UCIP - W. Wylie) FIELD_STRUCT_DESC: 8-inch steel irrigation pipe through the levee, 3.3 feet below levee crown. Electrical conduit through levee. Pump house located on waterside (WS) berm. Siphon breaker on WS shoulder, standpipe located 10 feet from landside (LS) toe. (8-inch pipe authorized under Permit No. 15098, 1989 - G. La Baume, permit also includes authorization of 12-inch pipe at different location). [Additional Reference(s): DWR Levee Logs, 1981, 2003] FS Date: 5/19/2015

View of LS. No appurtenances noted.

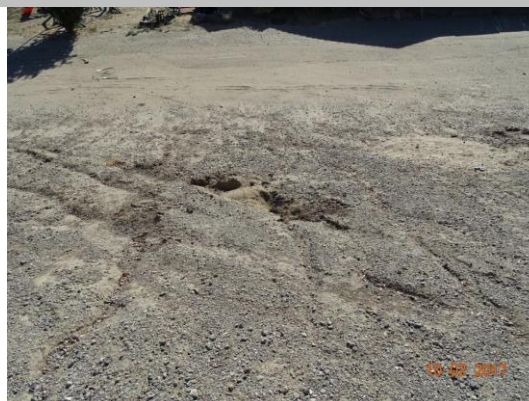
Photo 1 of 1 : FA_2018_RD0017_304_70_20180906_00011.jpg

LM Start	1.43	Rating **	M	Issue No.	70
LM End	1.43	Issue Type +	Ma	Location *	LS
Category	Earthen Levee			GPS Latitude/Longitude	
				Start	End
Item	Slope Stability			37.897508 °	37.897508 °
				-121.326671 °	-121.326671 °
DWR ID	DWR_RD0017_02_f_2017_70				
Comment Code					
S3 : Repair the levee slope damaged by vehicle traffic and prevent access where possible.					
Inspector Comment

Looking east at the landside slope.

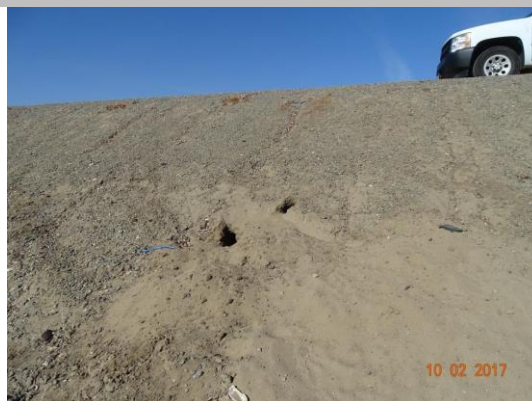
Photo 1 of 1 : FA_2018_RD0017_304_75_20180906_00013.jpg

LM Start	1.43	Rating **	M	Issue No.	75
LM End	1.43	Issue Type +	Ma	Location *	LS
Category	Earthen Levee			GPS Latitude/Longitude	
				Start	End
Item	Animal Control			37.897467 °	37.897467 °
				-121.326690 °	-121.326690 °
DWR ID	DWR_RD0017_02_f_2017_75				
Comment Code					
A3 : No rodents visible, but rodent burrows visible; need to backfill and compact or grout burrows.					
Inspector Comment

Looking west at the landside slope.

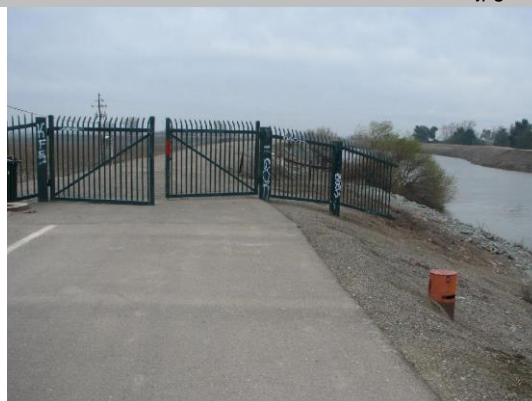
Photo 1 of 3 : UCIP_FA_2018_40639_38687.jpg

Comment Code					
Inspector Comment					
FS_ID:40639 DS_ID:11 EP_NO: 15316 Repair Type: Non-Urgent Crossing Status: Indicator Found UCIP Comments: Need to contact owner to determine status--pipe was not found only siphon breaker housing unit. FIELD_STRUCT_DESC: 8-inch steel drainage pipeline through levee, 3 feet below levee crown. Siphon breaker on the waterside (WS) shoulder. Pump is located inside ditch located approximately 75 feet landside (LS) of levee toe. (8-inch pipe authorized under Permit No. 15316, 1989 - W. Long and Reclamation No. 17 [RD0017], 10-inch pipe also installed) [Additional Reference(s): DWR Levee Logs, 1981, 2003, 8-inch pipe listed] FS Date: 2/4/2010

View of levee crown at crossing.

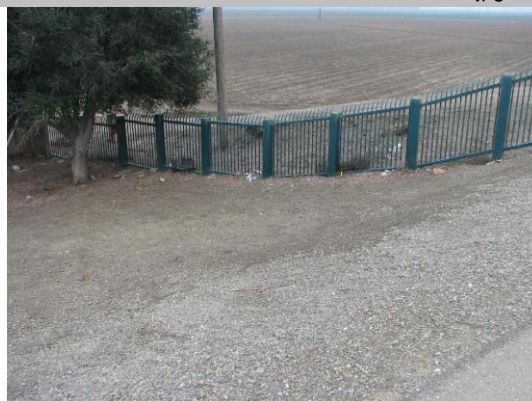
Photo 2 of 3 : UCIP_FA_2018_40639_38686.jpg

Comment Code						
Inspector Comment						
FS_ID:40639						
DS_ID:11						
EP_NO: 15316						
Repair Type: Non-Urgent						
Crossing Status: Indicator Found						
UCIP Comments: Need to contact owner to determine status--pipe was not found only siphon breaker housing unit.						
FIELD_STRUCT_DESC: 8-inch steel drainage pipeline through levee, 3 feet below levee crown. Siphon breaker on the waterside (WS) shoulder. Pump is located inside ditch located approximately 75 feet landside (LS) of levee toe. (8-inch pipe authorized under Permit No. 15316, 1989 - W. Long and Reclamation No. 17 [RD0017], 10-inch pipe also installed) [Additional Reference(s): DWR Levee Logs, 1981, 2003, 8-inch pipe listed]						
FS Date: 2/4/2010

View of landward side.

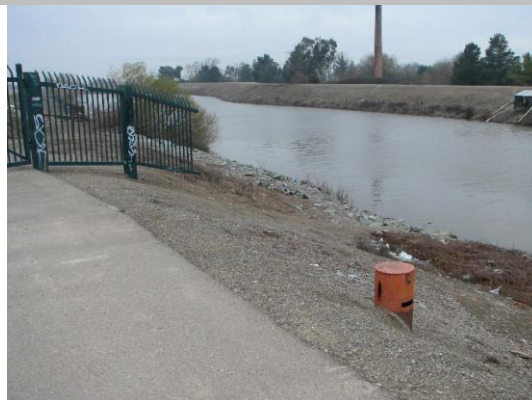
Photo 3 of 3 : UCIP_FA_2018_40639_38685.jpg

Siphon breaker located on waterward slope.

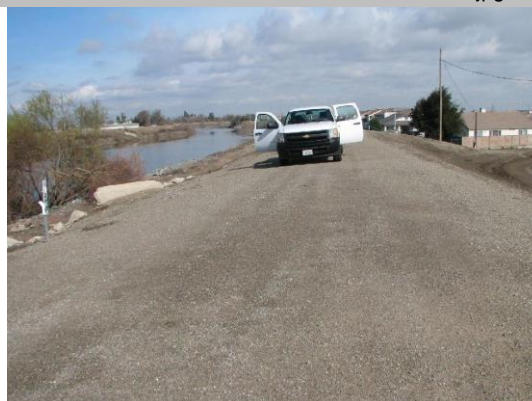
Photo 1 of 3 : UCIP_FA_2018_40640_71981.jpg

Comment Code						
Inspector Comment						
FS_ID:40640						
DS_ID:12						
EP_NO: 15099						
Repair Type: Non-Urgent						
Crossing Status: Found						
UCIP Comments: Need to coordinate with owner to determine status of crossing. If crossing is no longer in use owner will need to contact the CVFPB to comply with Title 23.						
FIELD_STRUCT_DESC: 16-inch steel irrigation pipe through levee, 2.30 feet below levee crown. Siphon breaker on waterside (WS) shoulder. Pump house located on the WS berm. Standpipe located 15 feet from landside (LS) toe. Concrete stairway on WS slope. (16-inch pipe removed under Permit No. 15099, 1989 - W. Long, 12-inch pipe removed) [Additional Reference(s): DWR Levee Logs, 1981, 2003]						
FS Date: 2/4/2010

View of levee crown at crossing.

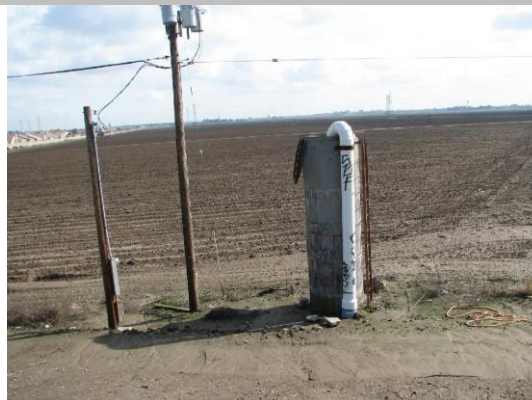
Photo 2 of 3 : UCIP_FA_2018_40640_38706.jpg

Standpipe located on landward side.

Comment Code						
Inspector Comment						
FS_ID:40640						
DS_ID:12						
EP_NO: 15099						
Repair Type: Non-Urgent						
Crossing Status: Found						
UCIP Comments: Need to coordinate with owner to determine status of crossing. If crossing is no longer in use owner will need to contact the CVFPB to comply with Title 23.						
FIELD_STRUCT_DESC: 16-inch steel irrigation pipe through levee, 2.30 feet below levee crown. Siphon breaker on waterside (WS) shoulder. Pump house located on the WS berm. Standpipe located 15 feet from landside (LS) toe. Concrete stairway on WS slope. (16-inch pipe removed under Permit No. 15099, 1989 - W. Long, 12-inch pipe removed) [Additional Reference(s): DWR Levee Logs, 1981, 2003]						
FS Date: 2/4/2010

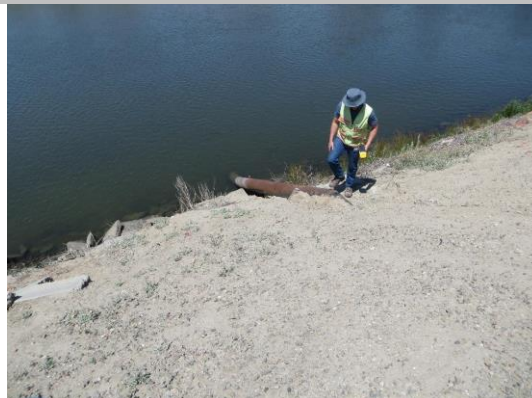
Photo 1 of 3 : UCIP_FA_2018_49640_74436.jpg

FS_ID:49640
DS_ID:13
EP_NO: 15100
Repair Type: Non-Urgent
Crossing Status: Found
UCIP Comments: 09/07/2016 Need to coordinate with owner to determine if 12-inch pipe was sleeved through authorized 16-inch pipe. Unable to confirm if 12-inch pipe was authorized under Permit No. 15100. Also need to coordinate with owner to determine extent of repair to crossing--previous leak to WS pipe section. (DWR UCIP - O. Magana)05/19/2015 Notes were initially recorded under DS_ID entry 82 due to field confirmed pipe size (12-inch and not 16-inch as described in permit). Record was updated to show 12 inch crossing was authorized under Permit 15100. **UPDATED INFO @ CROSSING:** Damage pipe section located on waterward toe has been replaced with new section. (DWR UCIP - O. Magana)02/0/2010 Holes in pipe at WS toe good indicator of pipe internal condition. Owner should perform an internal inspection of the pipe through the levee. (DWR UCIP - O. Magana)

(2015) Damage pipe section located on WS toe has been replaced.

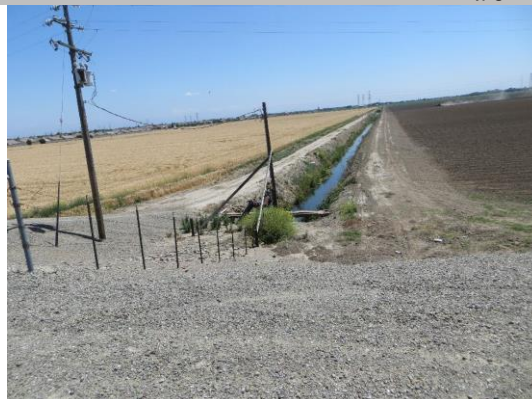
Photo 2 of 3 : UCIP_FA_2018_49640_74437.jpg

(2015) View of landward side.

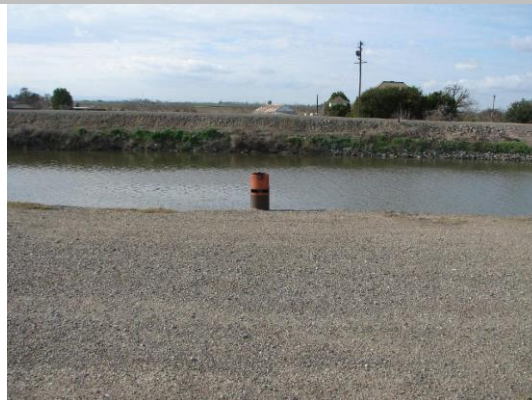
Photo 1 of 3 : UCIP_FA_2018_40642_38742.jpg

Comment Code						
Inspector Comment						
FS_ID:40642 DS_ID:14 EP_NO: 15317 Repair Type: Non-Urgent Crossing Status: Found UCIP Comments: Need to coordinate with owner to determine status of crossing. Need to find out if pipe located on landward side is tied to pipe through levee. Pipe found on waterward side is filled with concrete (non-functional). FIELD_STRUCT_DESC: 10-inch steel drainage pipe through levee, 3.91 feet below levee crown. Siphon breaker on waterside (WS) slope. Pump in ditch located 300 feet landside (LS) of toe. Ramp on LS slope. 10-inch pipe connects to an existing 16-inch discharge pipe on the LS. (10-inch installed under Permit No. 15317, 1990 - Calcagno Farms and Reclamation District 17 [RD0017], 16-inch section from levee removed; 10-pipe was installed during the levee work approved under Permit No. 15014, 1989 - RD0017). [Additional Reference(s): DWR Levee Logs, 1981, 2003] FS Date: 2/4/2010

View of waterward side--riser located on waterward shoulder.

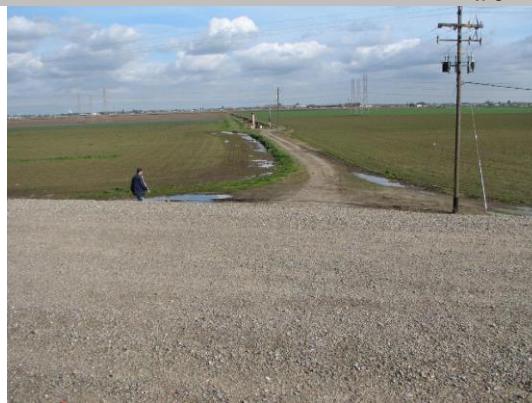
Photo 2 of 3 : UCIP_FA_2018_40642_38740.jpg

View of landward side.

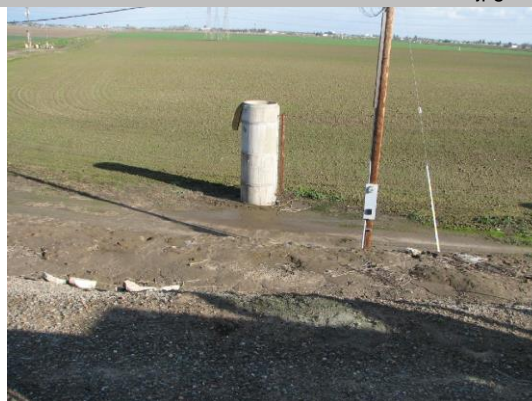
Photo 1 of 3 : UCIP_FA_2018_49992_38770.jpg

UCIP Comments: 7/12/2016 Rodent activity is present at this crossing. Unable to confirm if sink hole was present--depression near riser is still visible. Pipe was running during site visit. Crossing has been downgraded from Urgent to Non-Urgent--no damage was visible to levee crown or LS slope and only minor depression found around WS riser. Depression near siphon breaker on WS shoulder could be due to poor compaction or rodent activity--recommend monitoring site. Need to contact owner to determine if any internal integrity inspections have been done at this crossing. (DWR UCIP - omagana)2/04/2010 Sink hole present at siphon breaker riser located on waterward shoulder. Need to coordinate with owner to determine status of crossing. If crossing is no longer in use owner will need to contact the CVFPB to comply with Title 23. (DWR UCIP - omagana)

View of LS.

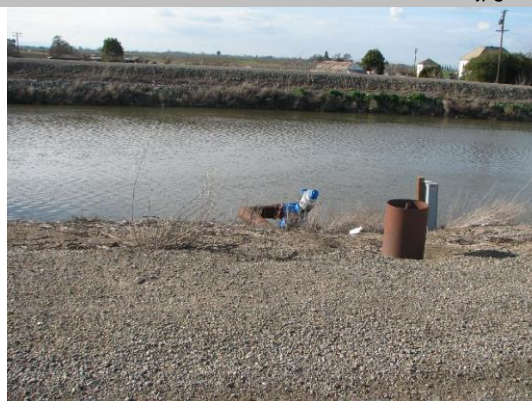
Photo 2 of 3 : UCIP_FA_2018_49992_38773.jpg

View of WS.

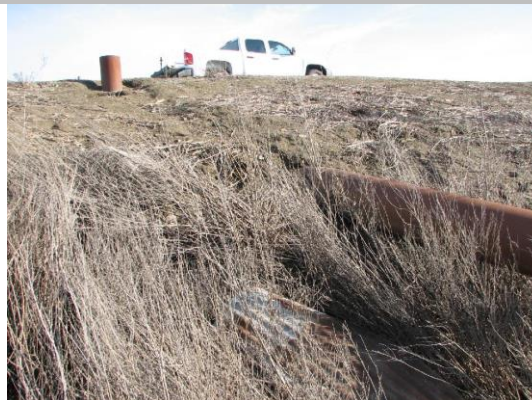
Photo 3 of 3 : UCIP_FA_2018_49992_38774.jpg

FS_ID:49992
DS_ID:15
EP_NO: 15101
Repair Type: Non-Urgent
Crossing Status: Found
UCIP Comments: 7/12/2016 Rodent activity is present at this crossing. Unable to confirm if sink hole was present--depression near riser is still visible. Pipe was running during site visit. Crossing has been downgraded from Urgent to Non-Urgent--no damage was visible to levee crown or LS slope and only minor depression found around WS riser. Depression near siphon breaker on WS shoulder could be due to poor compaction or rodent activity--recommend monitoring site. Need to contact owner to determine if any internal integrity inspections have been done at this crossing. (DWR UCIP - omagana)2/04/2010 Sink hole present at siphon breaker riser located on waterward shoulder. Need to coordinate with owner to determine status of crossing. If crossing is no longer in use owner will need to contact the CVFPB to comply with Title 23. (DWR UCIP - omagana)

View of WS slope--riser and pipe visible.

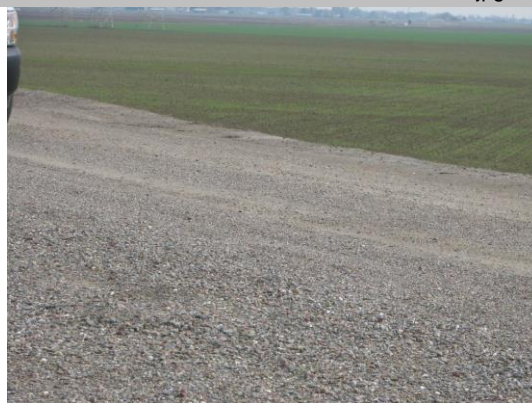
Photo 1 of 3 : UCIP_FA_2018_40645_72002.jpg

Comment Code					
Inspector Comment					
FS_ID:40645 DS_ID:16 EP_NO: 15102 Repair Type: Non-Urgent Crossing Status: Found UCIP Comments: Need to coordinate with owner to determine status of crossing. FIELD_STRUCT_DESC: 20-inch steel irrigation pipeline through levee. Invert of pipe is 2.8 feet below levee crown. Fill placed over the pipeline to provide 2.0 feet of cover. Siphon breaker on waterside (WS) shoulder. Pump on platform with walkway to shoulder, standpipe located 15 feet landside (LS) toe, concrete stairway en waterside (WS) slope. (20-inch pipe installed under Permit No. 15102, 1990 - Calcagno Farms Co-Partnership, also 24-inch pipe removed; 20-inch pipe was installed during the levee work approved under Permit No. 15014, 1989 - Reclamation District 17 [RD0017]). [Additional Reference(s): DWR Levee Logs, 1981, 2003] FS Date: 2/4/2010

View of levee crown at crossing.

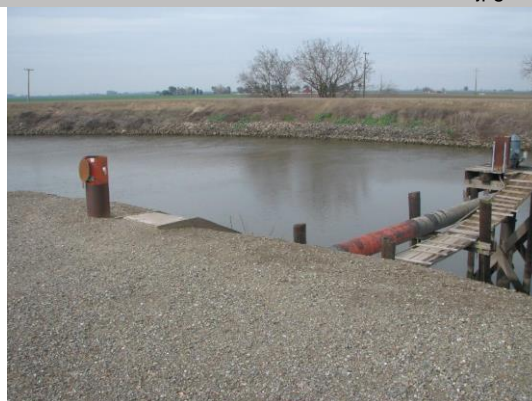
Photo 3 of 3 : UCIP_FA_2018_40645_72006.jpg

Comment Code						
Inspector Comment						
FS_ID:40645 DS_ID:16 EP_NO: 15102 Repair Type: Non-Urgent Crossing Status: Found UCIP Comments: Need to coordinate with owner to determine status of crossing. FIELD_STRUCT_DESC: 20-inch steel irrigation pipeline through levee. Invert of pipe is 2.8 feet below levee crown. Fill placed over the pipeline to provide 2.0 feet of cover. Siphon breaker on waterside (WS) shoulder. Pump on platform with walkway to shoulder, standpipe located 15 feet landside (LS) toe, concrete stairway on waterside (WS) slope. (20-inch pipe installed under Permit No. 15102, 1990 - Calcagno Farms Co-Partnership, also 24-inch pipe removed; 20-inch pipe was installed during the levee work approved under Permit No. 15014, 1989 - Reclamation District 17 [RD0017]). [Additional Reference(s): DWR Levee Logs, 1981, 2003] FS Date: 2/4/2010

Overview of waterward side.

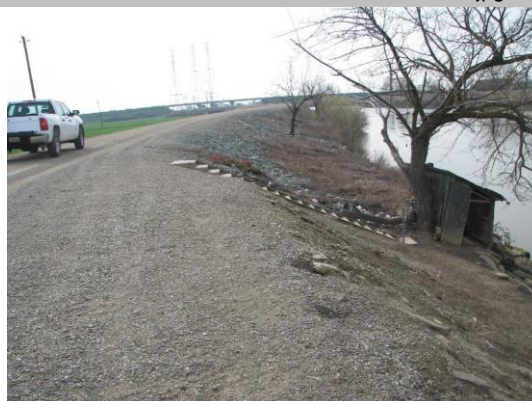
Photo 1 of 3 : UCIP_FA_2018_40646_72010.jpg

Comment Code						
Inspector Comment						
FS_ID:40646 DS_ID:17 EP_NO: 15103 Repair Type: Non-Urgent Crossing Status: Found UCIP Comments: Need to coordinate with owner to determine status of crossing. If crossing is no longer in use owner will need to contact the CVFPB to comply with Title 23. FIELD_STRUCT_DESC: 8-inch steel irrigation pipe through levee. Invert of pipe is 3.47 feet below crown. Siphon breaker on landside (LS) shoulder. Pump house on waterside (WS) slope, standpipe located 10 feet from LS toe. Concrete stairway on WS slope. (new 8-inch authorized under Permit No. 15103, 1990 - C. Young, existing 8-inch pipe removed; new 8-inch pipe was installed during the levee work approved under Permit No. 15014) [Additional Reference(s): DWR Levee Logs, 1981, 2003] FS Date: 2/4/2010

View of waterward side.

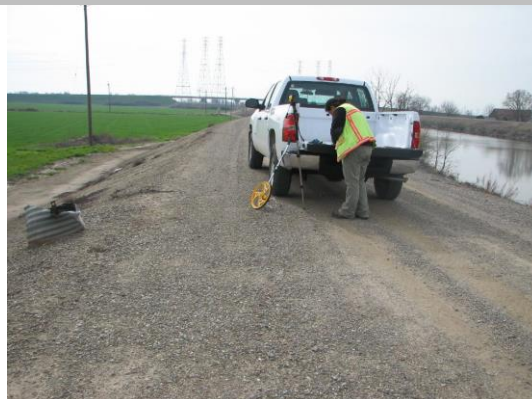
Photo 2 of 3 : UCIP_FA_2018_40646_72009.jpg

View of levee crown at crossing.

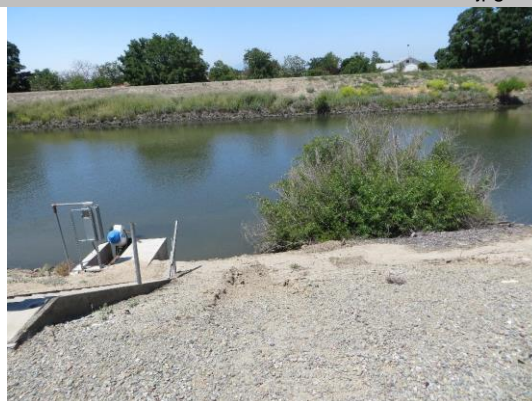
Photo 1 of 3 : UCIP_FA_2018_46009_74439.jpg

Comment Code						
Inspector Comment						
FS_ID:46009 DS_ID:315 EP_NO: N/A Repair Type: Non-Urgent Crossing Status: Found UCIP Comments: 05/19/15 Pipe has been removed. Need to contact KSN, engineering consultants for LMA, to obtain records showing pipe removal and obtain permit authoring work. 02/04/10 Hole present on waterward side pipe--historical records indicate crossing abandoned however unable to confirm. Unable to confirm condition of pipe through levee. Need to coordinate with owner to determine status of crossing. If crossing is no longer in use owner will need to contact the CVFPB to comply with Title 23. FIELD_STRUCT_DESC: *REMOVED* 4-inch irrigation pipe of unknown material through the levee, 2 feet below the crown. Pipe open on both ends, waterside (WS) and landside (LS). Pump on concrete pad and gate valve located on the WS slope. [Additional Reference(s): DWR Levee Logs, 1981, 2003] FS Date: 5/19/2015

(2015) View of waterward slope.

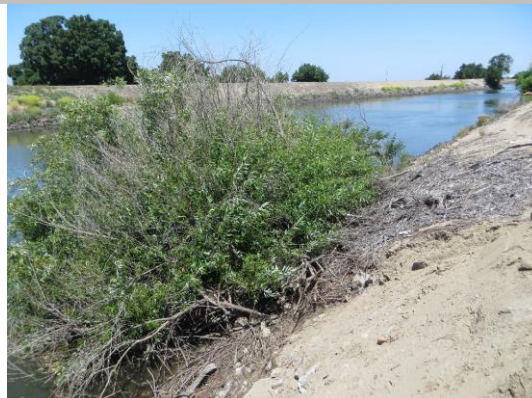
Photo 3 of 3 : UCIP_FA_2018_46009_74438.jpg

Comment Code						
Inspector Comment						
FS_ID:46009 DS_ID:315 EP_NO: N/A Repair Type: Non-Urgent Crossing Status: Found UCIP Comments: 05/19/15 Pipe has been removed. Need to contact KSN, engineering consultants for LMA, to obtain records showing pipe removal and obtain permit authoring work. 02/04/10 Hole present on waterward side pipe--historical records indicate crossing abandoned however unable to confirm. Unable to confirm condition of pipe through levee. Need to coordinate with owner to determine status of crossing. If crossing is no longer in use owner will need to contact the CVFPB to comply with Title 23. FIELD_STRUCT_DESC: *REMOVED* 4-inch irrigation pipe of unknown material through the levee, 2 feet below the crown. Pipe open on both ends, waterside (WS) and landside (LS). Pump on concrete pad and gate valve located on the WS slope. [Additional Reference(s): DWR Levee Logs, 1981, 2003] FS Date: 5/19/2015

(2015) Pipe removed from waterward toe.

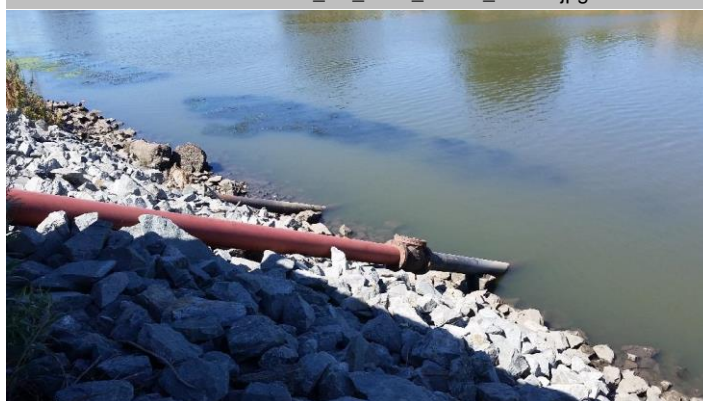
Photo 1 of 3 : UCIP_FA_2018_53329_75736.jpg

UCIP Comments: 9/5/2018 Same as last inspection. Recommend contacting owner to see if crossing still in use. Crossing remains Urgent because of pipe integrity (D. Sanoski - DWR UCIP).7/12/2016 Same as previous inspection. Holes visible along exposed WS section of pipe. (DWR UCIP - omagana)5/19/2015 Holes through pipe visible on waterward toe. Recommend contacting owner to confirm pipe use-- good candidate for internal inspection. (DWR UCIP - omagana)2/04/2010 Need to coordinate with owner to determine status of crossing. If crossing is no longer in use owner will need to contact the CVFPB to comply with Title 23. (DWR UCIP - omagana) FIELD_STRUCT_DESC: 8-inch steel irrigation pipe through the levee, 2.85 feet below levee crown. Pump station is located on waterside (WS). Concrete standpipe is located on the landside (LS) toe. (8-inch pipe authorized under Permit No. 15104, 1989-R. Romonda & C. Young, permit covers 4 pipe crossing removals and 3 new pipe installations; levee re-shaping authorized under Permit No. 15014, 1989 - Reclamation District 17 [RD0017]; pipe was installed as part of the re-shaping of RD17 project levees in 1989. The re-shaping of the levees was to increase levee elevations and provide freeboard above 100-year stages in both the San Joaquin River and French Camp Slough) [Additional Reference(s): DWR Levee Log, 1981 and 2003] FS Date: 9/5/2018 10:03:00 AM

View of WS, photo taken downstream looking at upstream pipe. Photo 1 of 2.

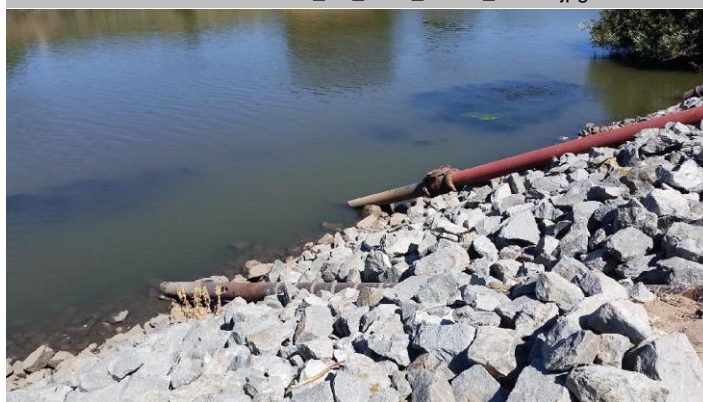
Photo 2 of 3 : UCIP_FA_2018_53329_75733.jpg

View of WS, photo taken upstream looking at first pipe. Photo 1 of 2.

FS_ID:53329
DS_ID:278
EP_NO: 15104
Repair Type: Urgent
Crossing Status: Found
UCIP Comments: 9/5/2018 Same as last inspection. Recommend contacting owner to see if crossing still in use. Crossing remains Urgent because of pipe integrity (D. Sanoski - DWR UCIP).7/12/2016 Same as previous inspection. Holes visible along exposed WS section of pipe. (DWR UCIP - omagana)5/19/2015 Holes through pipe visible on waterward toe. Recommend contacting owner to confirm pipe use-- good candidate for internal inspection. (DWR UCIP - omagana)2/04/2010 Need to coordinate with owner to determine status of crossing. If crossing is no longer in use owner will need to contact the CVFPB to comply with Title 23. (DWR UCIP - omagana) FIELD_STRUCT_DESC: 8-inch steel irrigation pipe through the levee, 2.85 feet below levee crown. Pump station is located on waterside (WS). Concrete standpipe is located on the landside (LS) toe. (8-inch pipe authorized under Permit No. 15104, 1989-R. Romonda & C. Young, permit covers 4 pipe crossing removals and 3 new pipe installations; levee re-shaping authorized under Permit No. 15014, 1989 - Reclamation District 17 [RD0017]; pipe was installed as part of the re-shaping of RD17 project levees in 1989. The re-shaping of the levees was to increase levee elevations and provide freeboard above 100-year stages in both the San Joaquin River and French Camp Slough) [Additional Reference(s): DWR Levee Log, 1981 and 2003] FS Date: 9/5/2018 10:03:00 AM

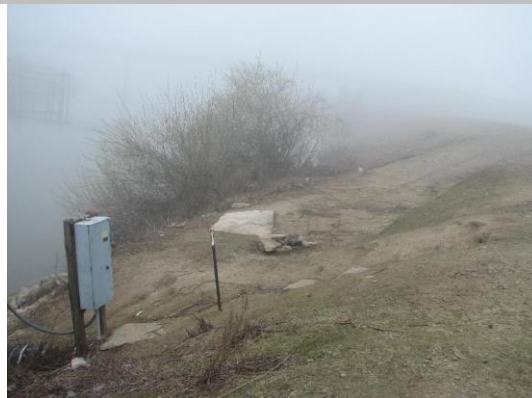
Photo 1 of 3 : UCIP_FA_2018_40655_72050.jpg

View of waterward side.

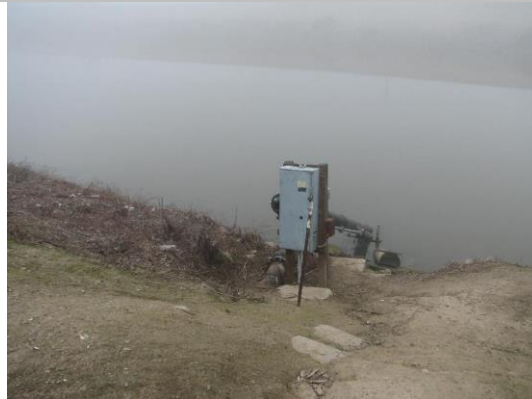
Photo 2 of 3 : UCIP_FA_2018_40655_72051.jpg

Pump station and control panel located on waterward side.

Comment Code						
Inspector Comment						
FS_ID:40655 DS_ID:20 EP_NO: 15106 Repair Type: Non-Urgent Crossing Status: Found UCIP Comments: Burrow activity dession on landward slope. Need to coordinate with owner to determine status of crossing. If crossing is no longer in use owner will need to contact the CVFPB to comply with Title 23. FIELD_STRUCT_DESC: 10-inch steel irrigation pipe through levee, 3.27 feet below levee crown. Siphon breaker on landside (LS) shoulder. Pump on waterside (WS) slope, standpipe located 14 feet LS of levee toe. (10-inch installed and existing 12-inch pipe removed under Permit No. 15106, 1989-A.J. Rodgers Estate - C/O Opal Rodgers; pipe was installed during the levee work approved under Permit Number 15014, 1989-Reclamation District No. 17 [RD0017]) [Additional Reference(s): DWR Levee Logs, 1981, 2003] FS Date: 2/4/2010

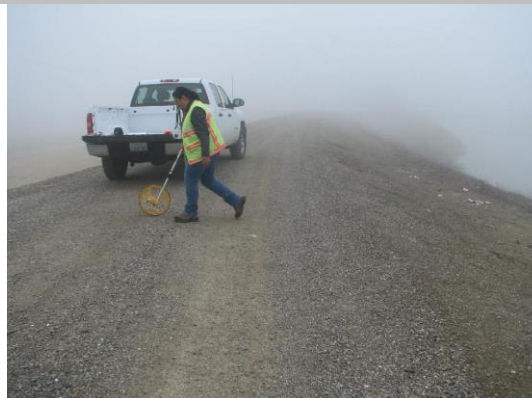
Photo 3 of 3 : UCIP_FA_2018_40655_72049.jpg

View of levee crown at crossing.

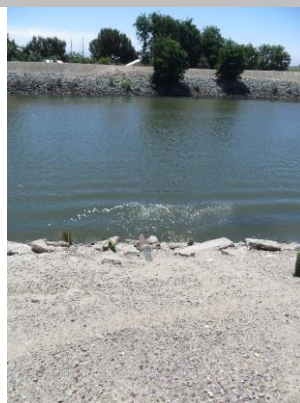
Photo 1 of 3 : UCIP_FA_2018_46005_74456.jpg

(2015) View of waterward side.

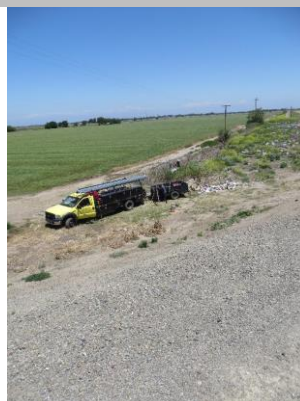
Photo 3 of 3 : UCIP_FA_2018_46005_74457.jpg

Comment Code						
Inspector Comment						
FS_ID:46005 DS_ID:21 EP_NO: 15310 Repair Type: Non-Urgent Crossing Status: Found UCIP Comments: 05/19/15 Deteriorated section of pipe has been replaced. Need to contact KSN, engineering consulting representing LMA, to determine repair details and to obtain permit authorizing repair.02/04/10 Pipe wall deteriorated. Need to coordinate with owner to determine status of crossing. If crossing is no longer in use owner will need to contact the CVFPB to comply with Title 23. FIELD_STRUCT_DESC: 10-inch steel drainage pipe through levee, 4-feet below crown. Siphon breaker on landside (LS) shoulder. Pump located on the LS approximately 45 feet from the levee toe. (10-inch pipe installed (per As-builts), 8-inch referenced in permit records, and existing 6-inch pipe removed (two existing pipes removed), work authorized under Permit No. 15310, 1989-O. Rodgers; 10-inch pipe was installed during the levee work approved under Permit No. 15014, 1989-Reclamation District No. 17 [RD0017]). [Additional Reference(s): DWR Levee Logs, 1981, 2003] FS Date: 5/19/2015

(2015) View of landward side.

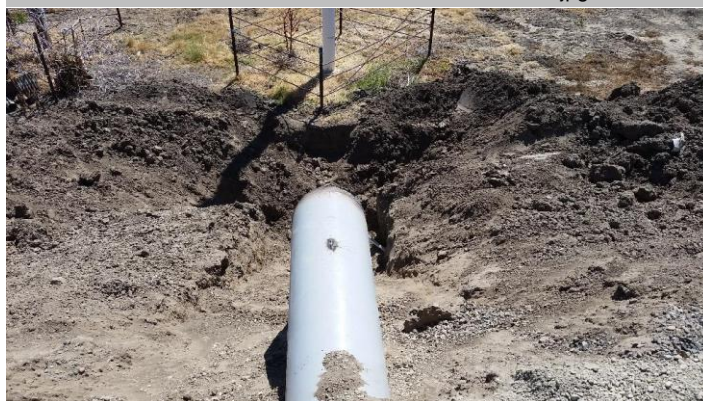
Photo 1 of 3 : UCIP_FA_2018_50004_75870.jpg

View of exposed pipe on LS--photo taken during install progress.

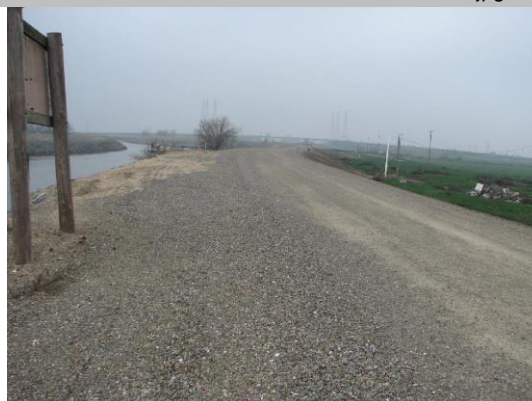
Photo 1 of 3 : UCIP_FA_2018_40658_72112.jpg

Comment Code						
Inspector Comment						
FS_ID:40658 DS_ID:23 EP_NO: 4116 Repair Type: Non-Urgent Crossing Status: Found UCIP Comments: Need to contact owner to determine status of crossing. Need date of last inspection and confirmation that crossing is still in operable condition. FIELD_STRUCT_DESC: 8.625-inch steel high pressure gas main through the levee. Invert of pipe is 3.9 feet below the crown. Location sign for gas pipeline crossing on waterside (WS) slope. PG&E contact information 510-779-4830 for crossing. (8.625-inch gas main authorized under Permit No. 4116, 1962-Pacific Gas and Electric Company [PG&E]) [Additional Reference(s): DWR Levee Logs, 1981, 2003] FS Date: 2/4/2010

View of levee crown at crossing.

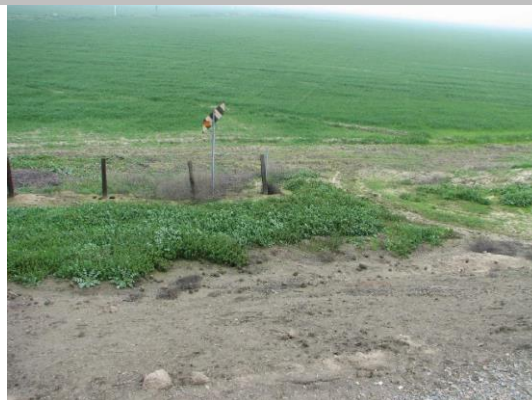
Photo 2 of 3 : UCIP_FA_2018_40658_72111.jpg

View of landward side.

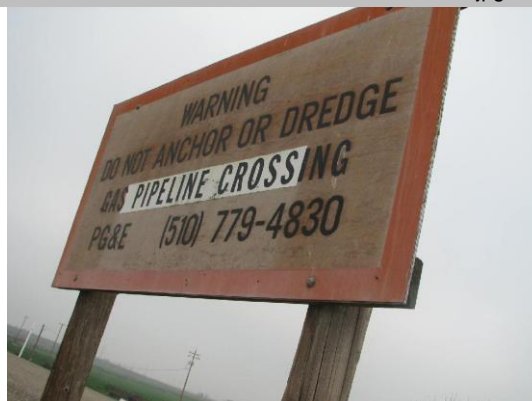
Photo 3 of 3 : UCIP_FA_2018_40658_72110.jpg

Comment Code						
Inspector Comment						
FS_ID:40658 DS_ID:23 EP_NO: 4116 Repair Type: Non-Urgent Crossing Status: Found UCIP Comments: Need to contact owner to determine status of crossing. Need date of last inspection and confirmation that crossing is still in operable condition. FIELD_STRUCT_DESC: 8.625-inch steel high pressure gas main through the levee. Invert of pipe is 3.9 feet below the crown. Location sign for gas pipeline crossing on waterside (WS) slope. PG&E contact information 510-779-4830 for crossing. (8.625-inch gas main authorized under Permit No. 4116, 1962-Pacific Gas and Electric Company [PG&E]) [Additional Reference(s): DWR Levee Logs, 1981, 2003] FS Date: 2/4/2010

Marker visible on waterward side.

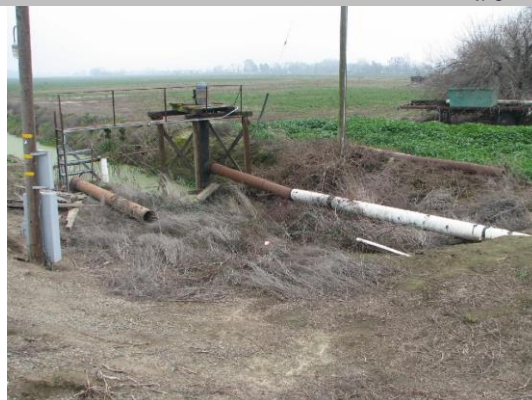
Photo 1 of 3 : UCIP_FA_2018_40659_72116.jpg

LM Start	3.63	Rating **	M	Issue No.	106
LM End	3.63	Issue Type +	En	Location *	
Category	Supplemental			GPS Latitude/Longitude	
				Start	End
Item	DWR UCIP Field Study			37.868657 °	37.868657 °
				-121.327383 °	-121.327383 °
DWR ID	26				
Comment Code					
Inspector Comment					
FS_ID:40659 DS_ID:26 EP_NO: 15109 Repair Type: Non-Urgent Crossing Status: Found UCIP Comments: Erosion around siphon breaker on landward side recommend investigating potential leak. FIELD_STRUCT_DESC: 12-inch steel drainage pipe through levee, 3 feet below levee crown. Siphon breaker on landside (LS) shoulder. Pump in irrigation ditch is located about 45 feet from LS toe. (12-inch pipe authorized under Permit No. 15109, 1990 - R. Muller) [Additional Reference(s): DWR Levee Logs, 1981, 2003] FS Date: 2/4/2010

View of pipe section and pump station located on landward side.

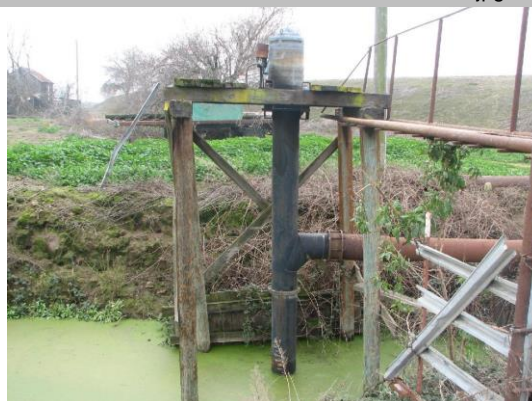
Photo 2 of 3 : UCIP_FA_2018_40659_72115.jpg

Pump station locate on landward side.

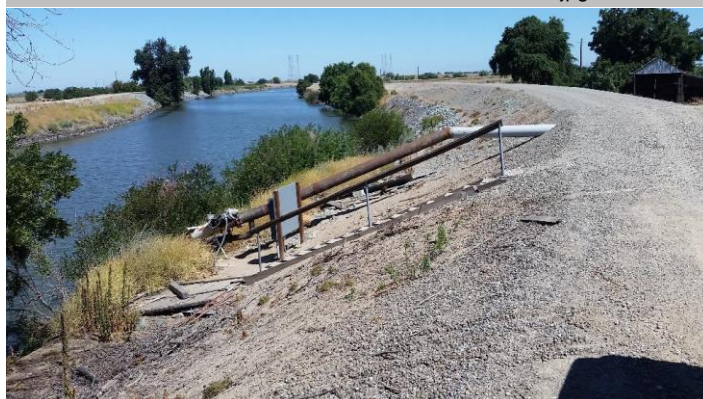
Photo 1 of 3 : UCIP_FA_2018_50005_75863.jpg

View of WS, photo taken looking downstream.

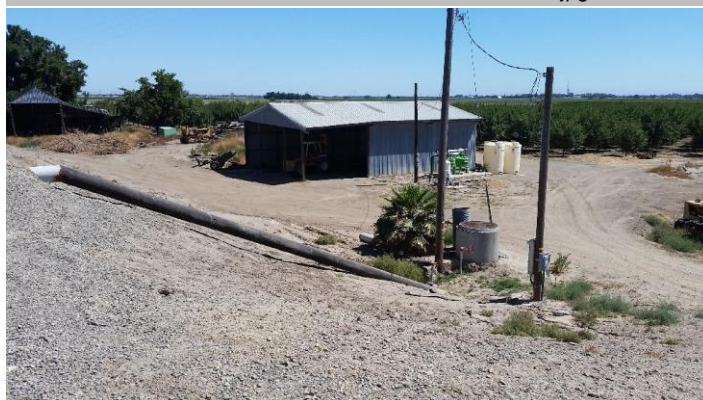
Photo 2 of 3 : UCIP_FA_2018_50005_75864.jpg

Comment Code						
Inspector Comment						
FS_ID:50005 DS_ID:25465 EP_NO: N/A Repair Type: Non-Urgent Crossing Status: Found UCIP Comments: 7/12/2016 Missing permit number and as-built drawings for this crossing. New pipe installed June 2016. According to Rick Toy, KSN-District Engineer, DCC Engineering is working with CVFPB to obtain permit for owner. Pipe replaces DS_ID 27--pipe removed May 2016. (DWR UCIP - omagana) FIELD_STRUCT_DESC: UNK-inch steel irrigation pipe through levee, X.XX feet below the crown. Slant pump is located on waterside (WS) slope, standpipe located 5 feet from LS toe. Concrete stairways with guardrail located on the WS. Two power poles (about 10 feet apart) located on landside (LS) toe. (Permit No. XXXXX, 2016 - XXXXXX) FS Date: 7/12/2016

View of LS, photo taken looking downstream.

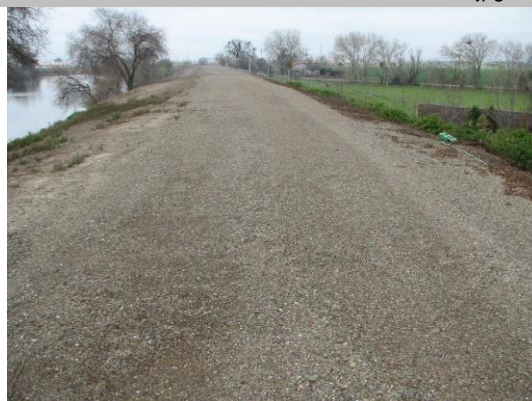
Photo 1 of 3 : UCIP_FA_2018_43264_72125.jpg

Comment Code						
Inspector Comment						
FS_ID:43264 DS_ID:28 EP_NO: 15111 Repair Type: Non-Urgent Crossing Status: Found UCIP Comments: 2/4/15--Olivia 2010 Records from KSN show this crossing was removed based on the RD17 As-Built Pipe Crossing Stationing Reference, however when field verification was completed in this area a 2-inch pipe was found. This could be a different 2-inch pipe in nearby area. Need to coordinate with owner to determine permit issued for this crossing. 2/4/10 Pipe is not continous. Need to coordinate with owner to determine status of crossing. If crossing is no longer in use owner will need to contact the CVFPB to comply with Title 23. FIELD_STRUCT_DESC: *REMOVED* 2-inch pipeline through levee, 3.92 feet (invert depth) below levee crown. Siphon breaker on landside (LS) shoulder. Pump on waterside (WS) slope. Pipe extends beyond 10 feet of the LS toe. (existing 2-inch removed under Permit No. 15111, 1990 - R. Jocopetti; 2-inch pipe was removed during the levee work approved under Permit No. 15014, 1989 - Reclamation District 17 [RD0017]) [Additional Reference(s): DWR Levee Logs, 1981, 2003] FS Date: 2/4/2010

View of levee crown at crossing.

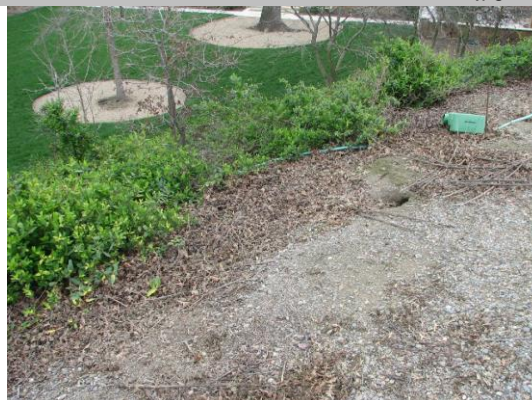
Photo 2 of 3 : UCIP_FA_2018_43264_72124.jpg

View of landward side.
